**Test Report for:**  
**KNAPHEIDE MANUFACTURING CO.**  
Attn: Mike Land  
**THERMAL CYCLE TEST**  
**One (1) 2015 Chevy City Express Van**

February 23, 2016  
Report No.: 102478898DET-001

## THERMAL CYCLE TEST

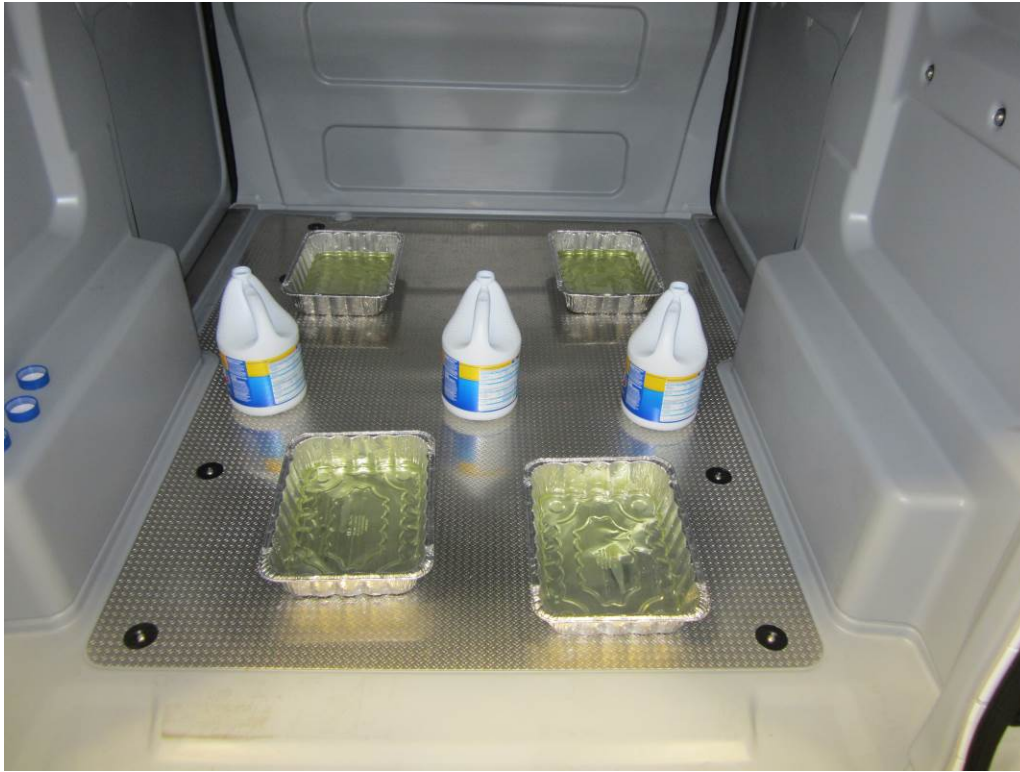
Photograph 1: Bleach Placement

Prior to testing, four (4) gallons of bleach were placed inside the rear of the vehicle. One gallon was used to fill four trays, and the other three (3) gallons were placed with the caps off. The meter was then placed over the bleach to confirm functionality. The van doors were closed and the vehicle was placed inside an environmental chamber. A pre-test meter reading was taken inside the vehicle cab and then the sample was subjected to the following:

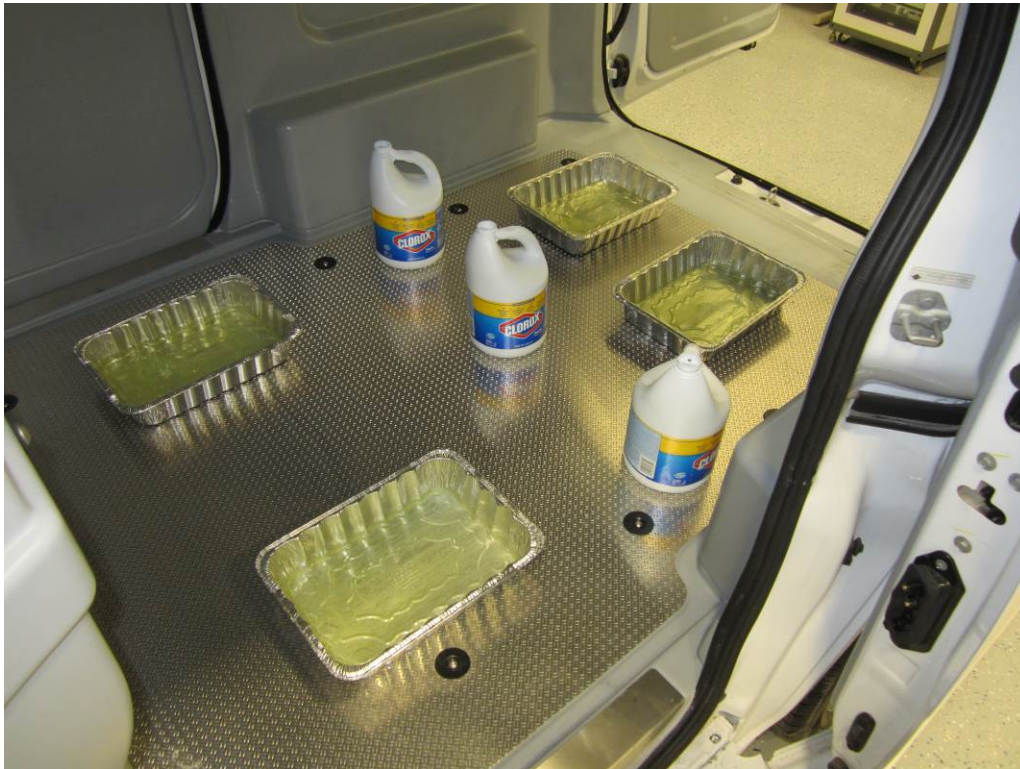
Photograph 2: Bleach Placement

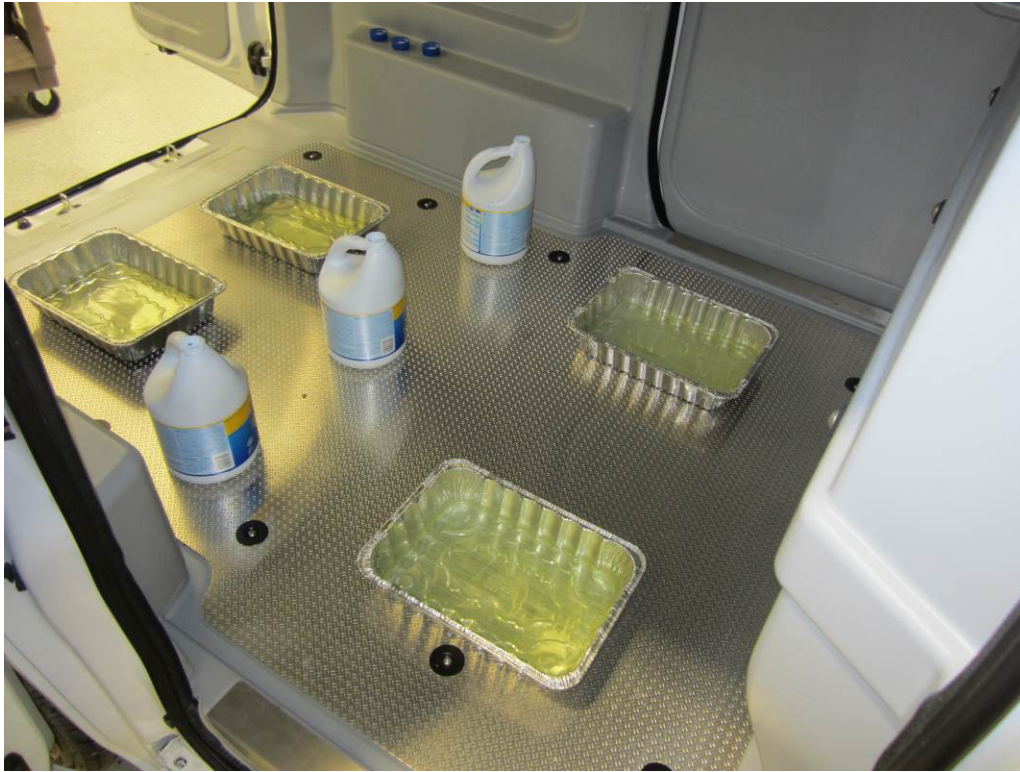
Photograph 3: Bleach Placement

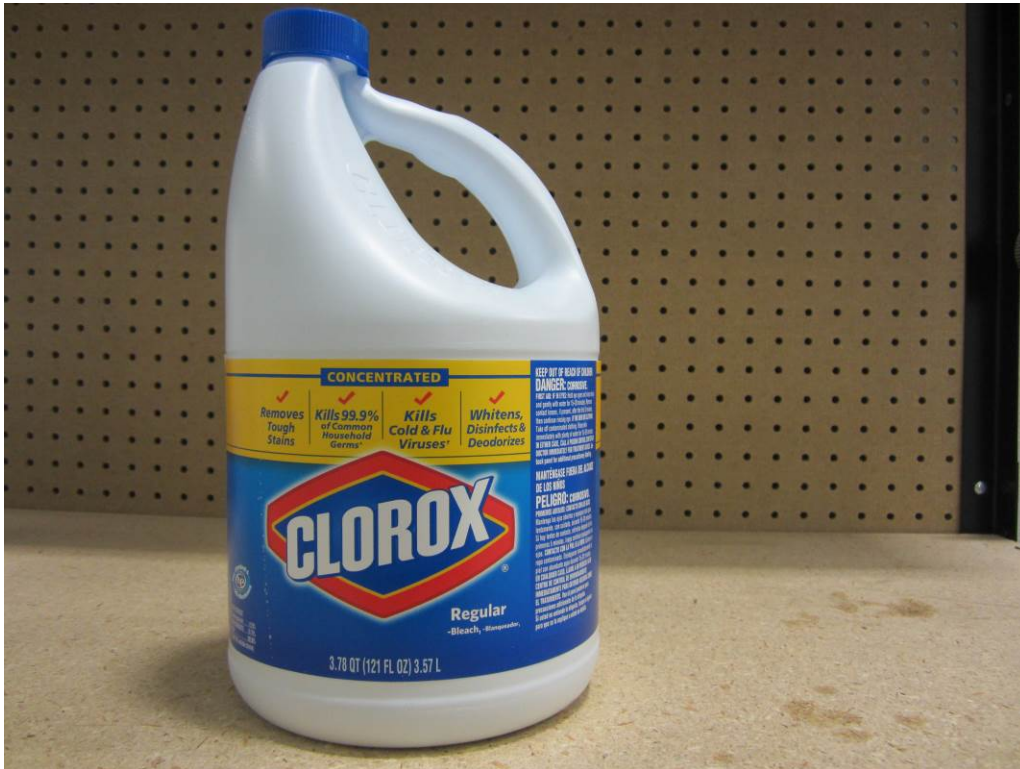
Photograph 4: Bleach

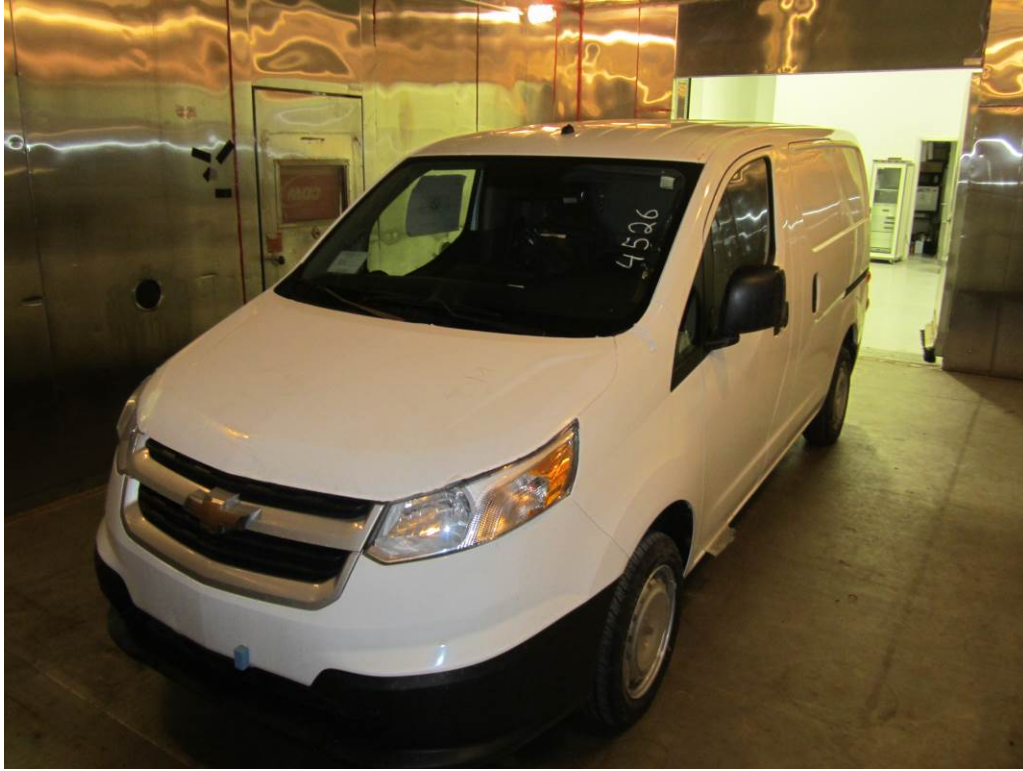
Photograph 5: Vehicle in Chamber

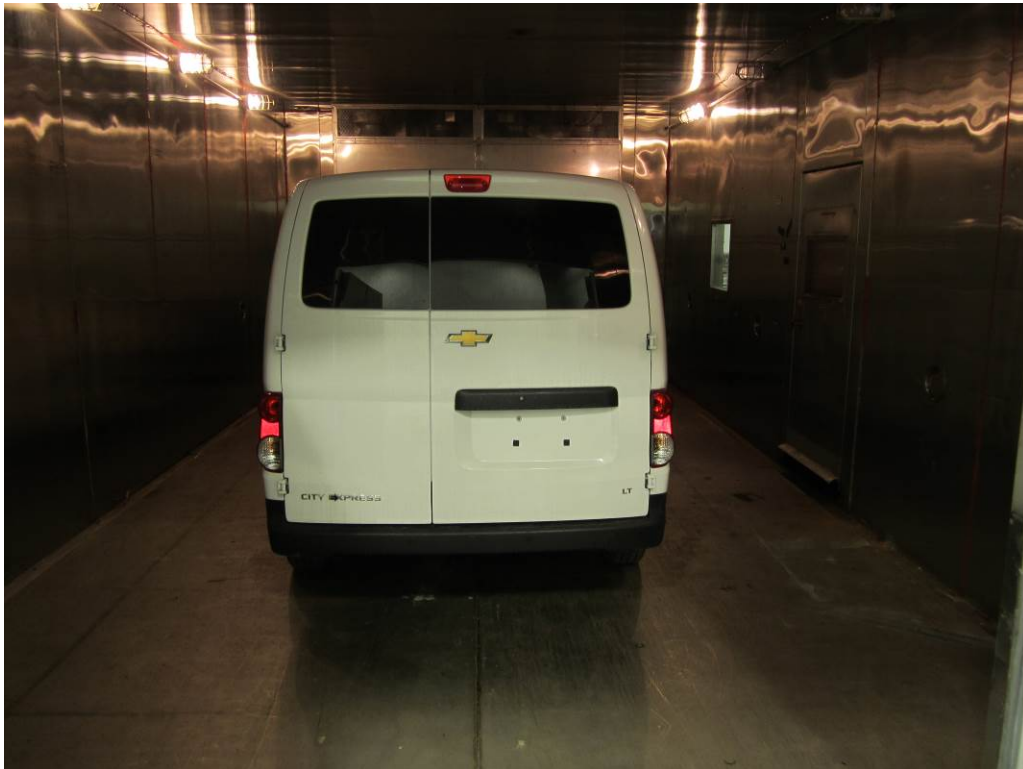
Photograph 6: Vehicle in Chamber

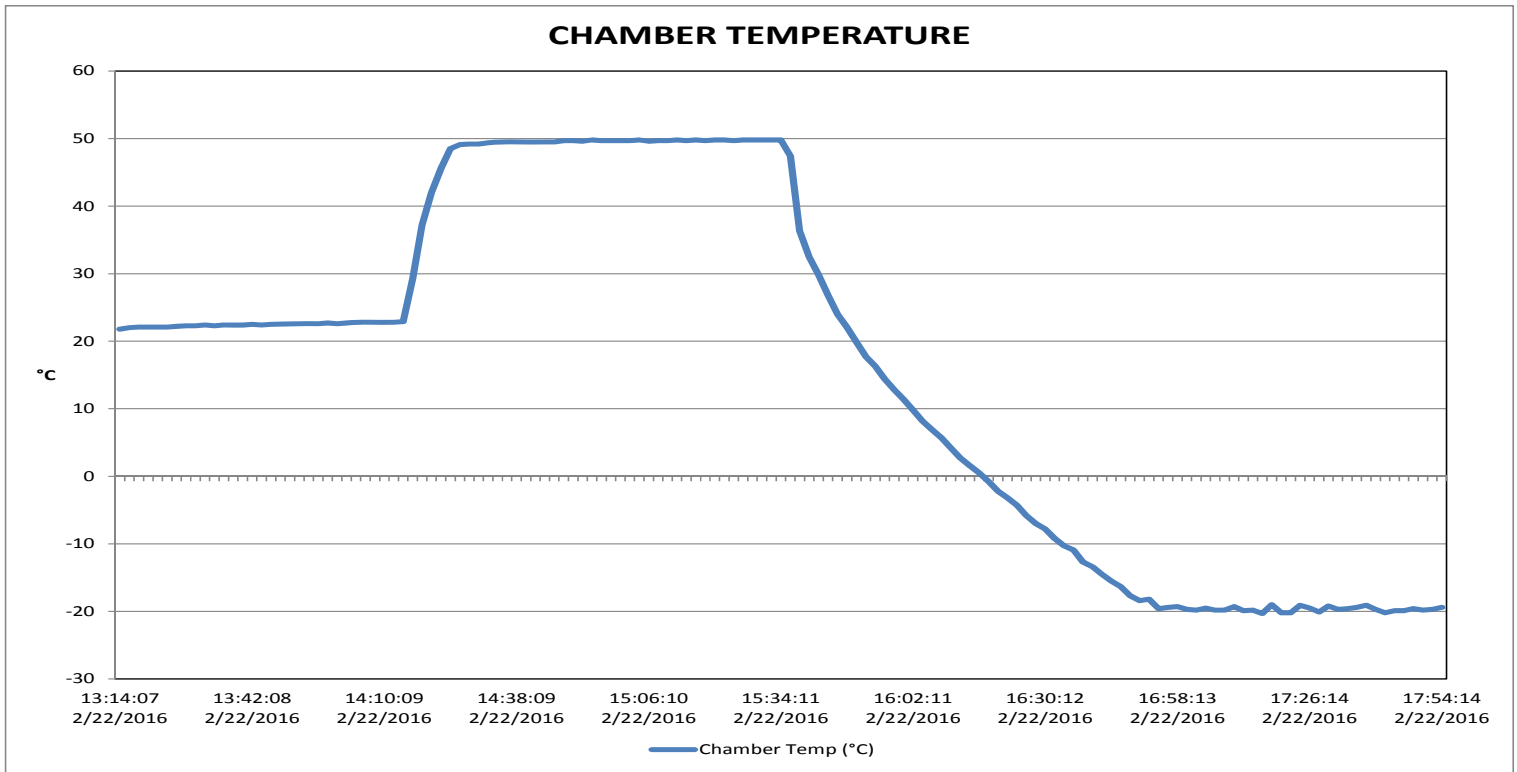
Figure 1: Chamber Profile

- One (1) hour soak at ambient temperature
- Three (3) people smelled the inside of the vehicle to see if bleach could be detected
- Meter reading taken
- One (1) hour soak at 50°C
- Three (3) people smelled the inside of the vehicle to see if bleach could be detected
- Meter reading taken
- One (1) hour soak at -20°C
- Three (3) people smelled the inside of the vehicle to see if bleach could be detected
- Meter reading taken

All meter readings conducted with the meter being inside the cab of the van for thirty (30) seconds.
